1 Introduction

Dualoy 3000/L pipe and fittings are manufactured from chemically inert thermosetting epoxy resins reinforced with high tensile strength fiberglass filaments. The pipe is produced by filament winding. The pipe incorporates a resin-rich inner liner that is resilient and holiday-free and a resin-rich outer coating that protects the resin-glass bond of the structural wall from UV radiation during storage and installation. The structural wall strength of Dualoy 3000/L pipe is unsurpassed in the fiberglass pipe industry. Fittings are manufactured by filament-winding or compression molding; injection molding is not employed.

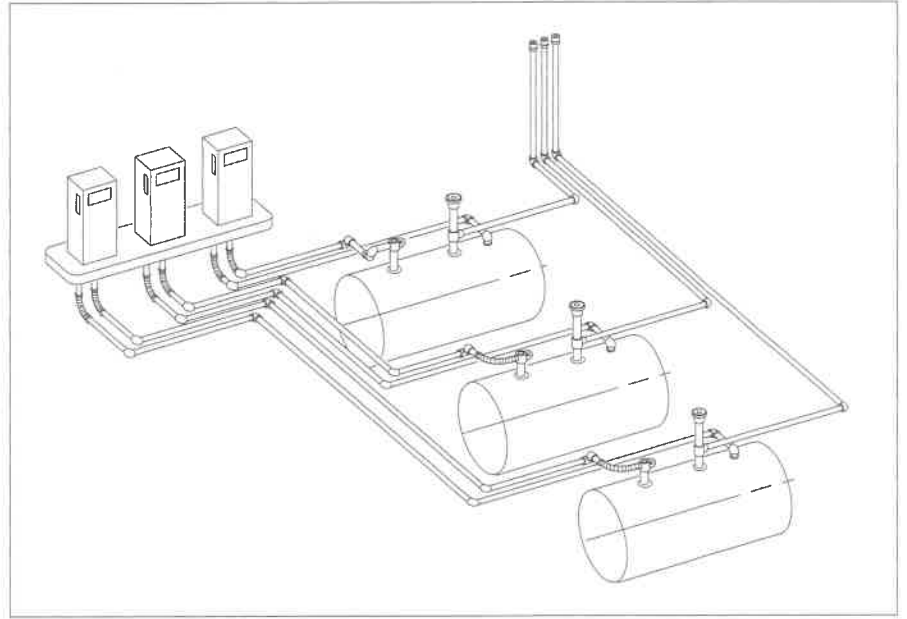
Fig. 1-1. A typical three-product service station layout employing Dualoy 3000/L fiberglass pipe for product piping and Stage I and Stage II vapor recovery lines. Dualoy 3000/L piping is also available for the complete line of secondary containment systems.
